**Jefferson Proving Ground  
South of the Firing Line**

**Final Asbestos Survey Summary Report**

**Volume III  
(Buildings 230 through 475)**

**September 1993**

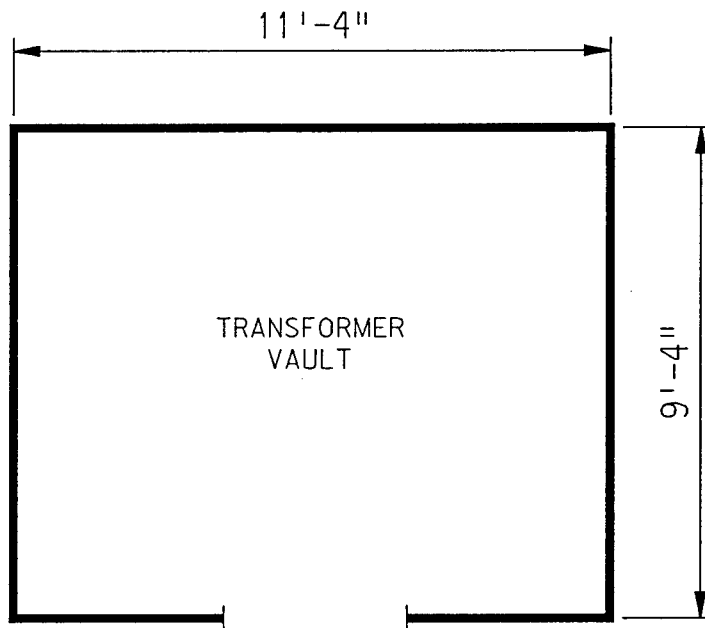
The general condition of ACM present was observed to be good with the noted exceptions above. ACM observed was nonfriable.

ASSUMED ASBESTOS ROOFING COMPONENTS  
ASSUMED ASBESTOS ELECTRICAL PANEL INSULATION

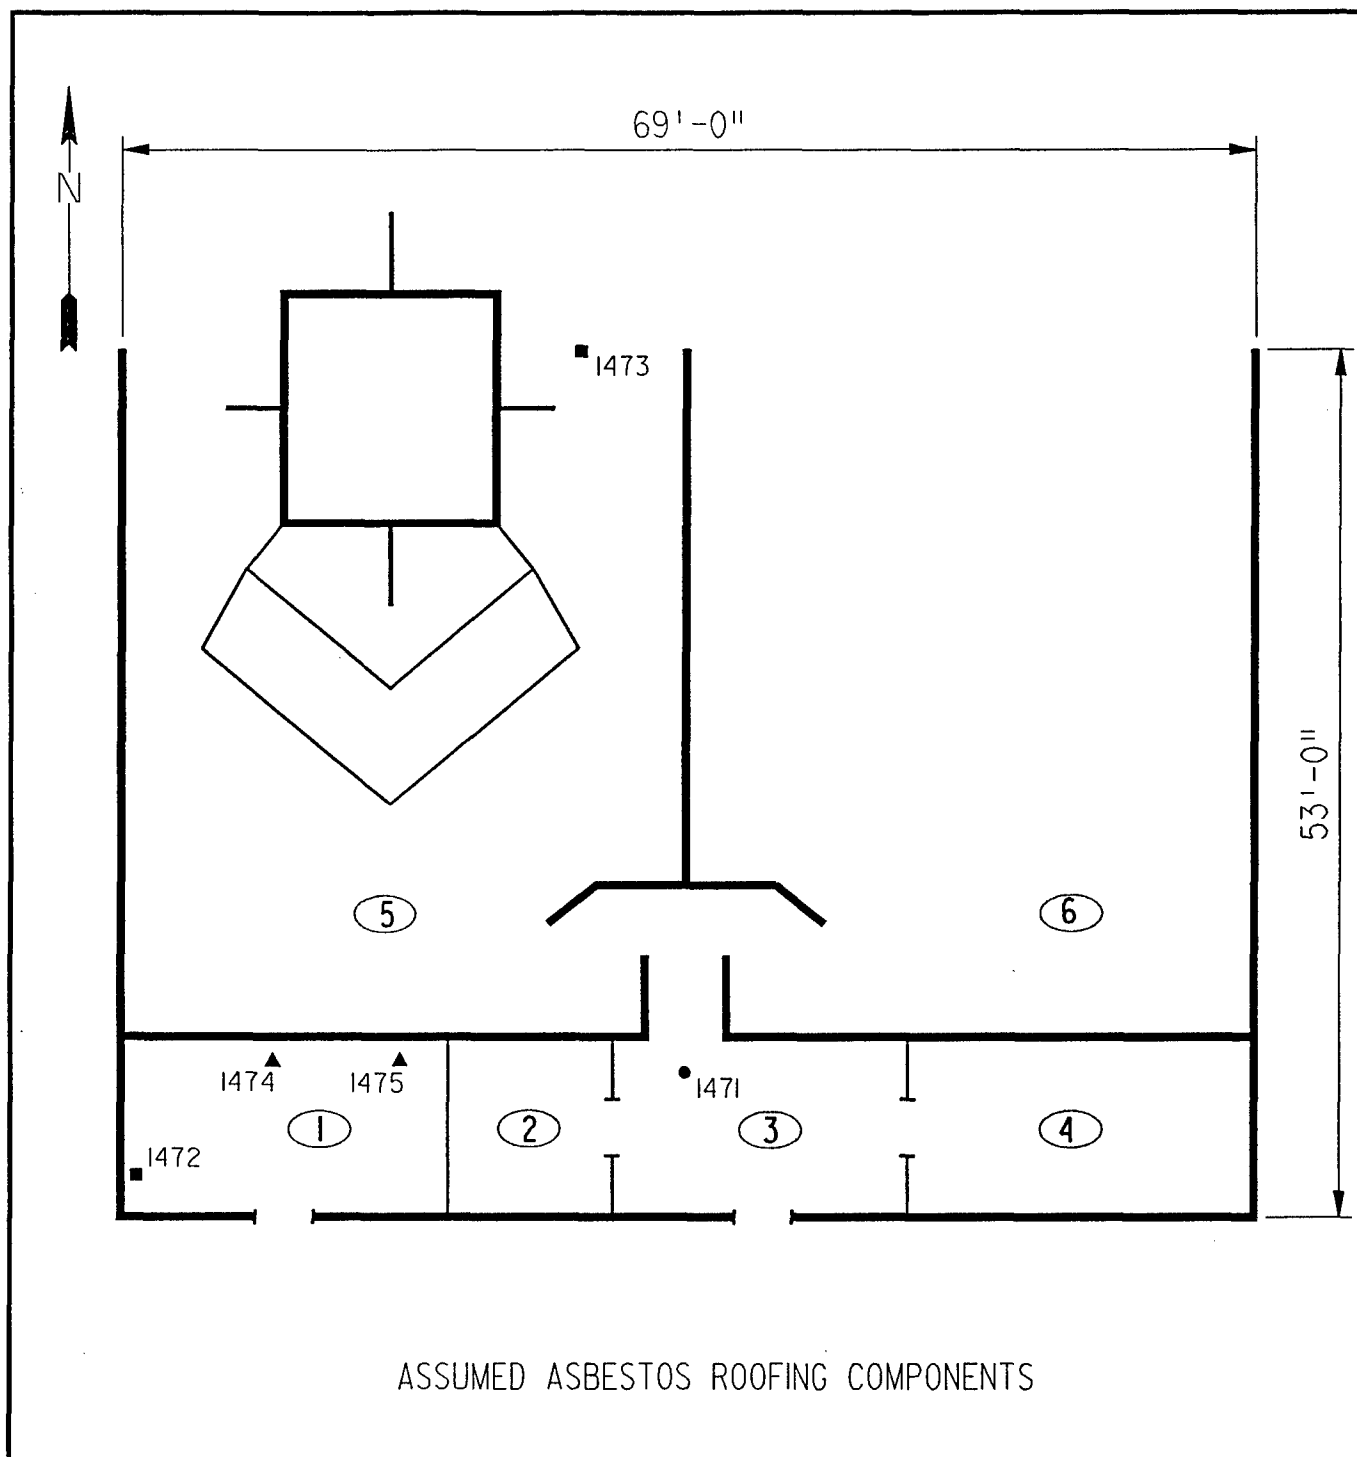
- 10 linear feet of pipe lagging insulation. This insulation was observed to be in generally good condition with evidence of minor isolated physical damage or material deterioration.
- 5 areas of packed "fitting" insulation on pipes otherwise insulated with lagging material. This insulation was observed to be in generally good condition with evidence of minor isolated physical damage or material deterioration.
- 600 square feet of vinyl floor tiles. These tiles were observed to be in fair condition with evidence of general physical damage or material deterioration.
- 700 square feet of roofing tars and felts. These tars and felts were inaccessible for inspection, but were assumed to be in satisfactory condition.

ACM pipe insulations were observed to be friable and in generally good condition. The remaining ACM was nonfriable.

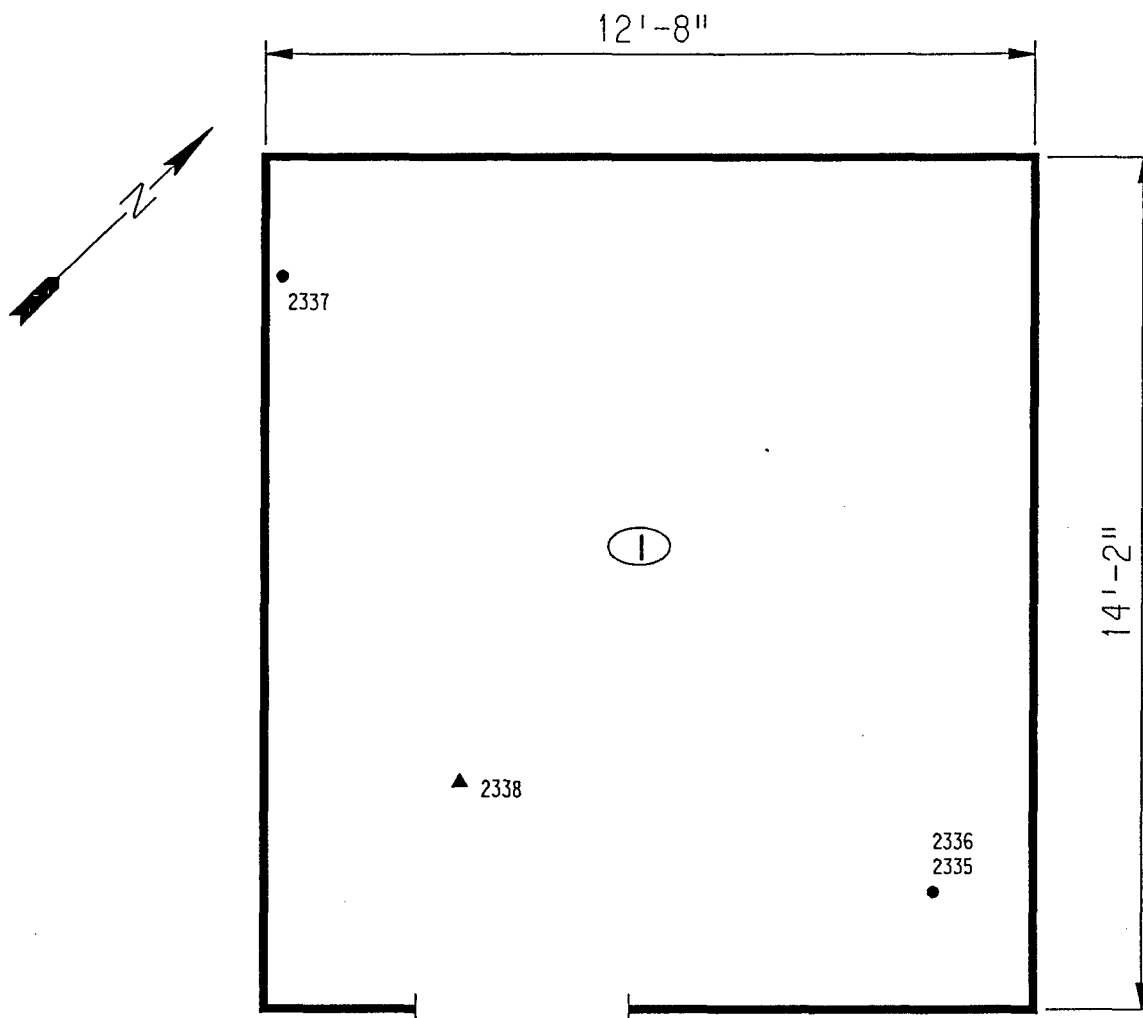
- 5 linear feet of white powdery pipe insulation ("white mag"). This insulation was observed to be in poor condition with evidence of significant physical damage or material deterioration.
- 5 areas of packed "fitting" insulation on pipes otherwise insulated with white powdery material. This insulation was observed to be in poor condition with evidence of significant physical damage or material deterioration.
- 120 square feet of 12" x 12" red and black vinyl floor tiles. These tiles were observed to be in poor condition with evidence of physical damage or material deterioration.
- 150 square feet of cement board ("Transite") roofing shingles. These shingles were observed to be in generally good condition with evidence of minor isolated physical damage or material deterioration.

Interior ACM was observed to be in significantly damaged condition. ACM pipe insulations were extremely friable. Interior ACM would need to be removed prior to safe reoccupation. Exterior ACM was in good condition and is nonfriable.

Access to the building's interior area needs to be controlled through locking doors and posting asbestos hazard warning signs in the doorways.

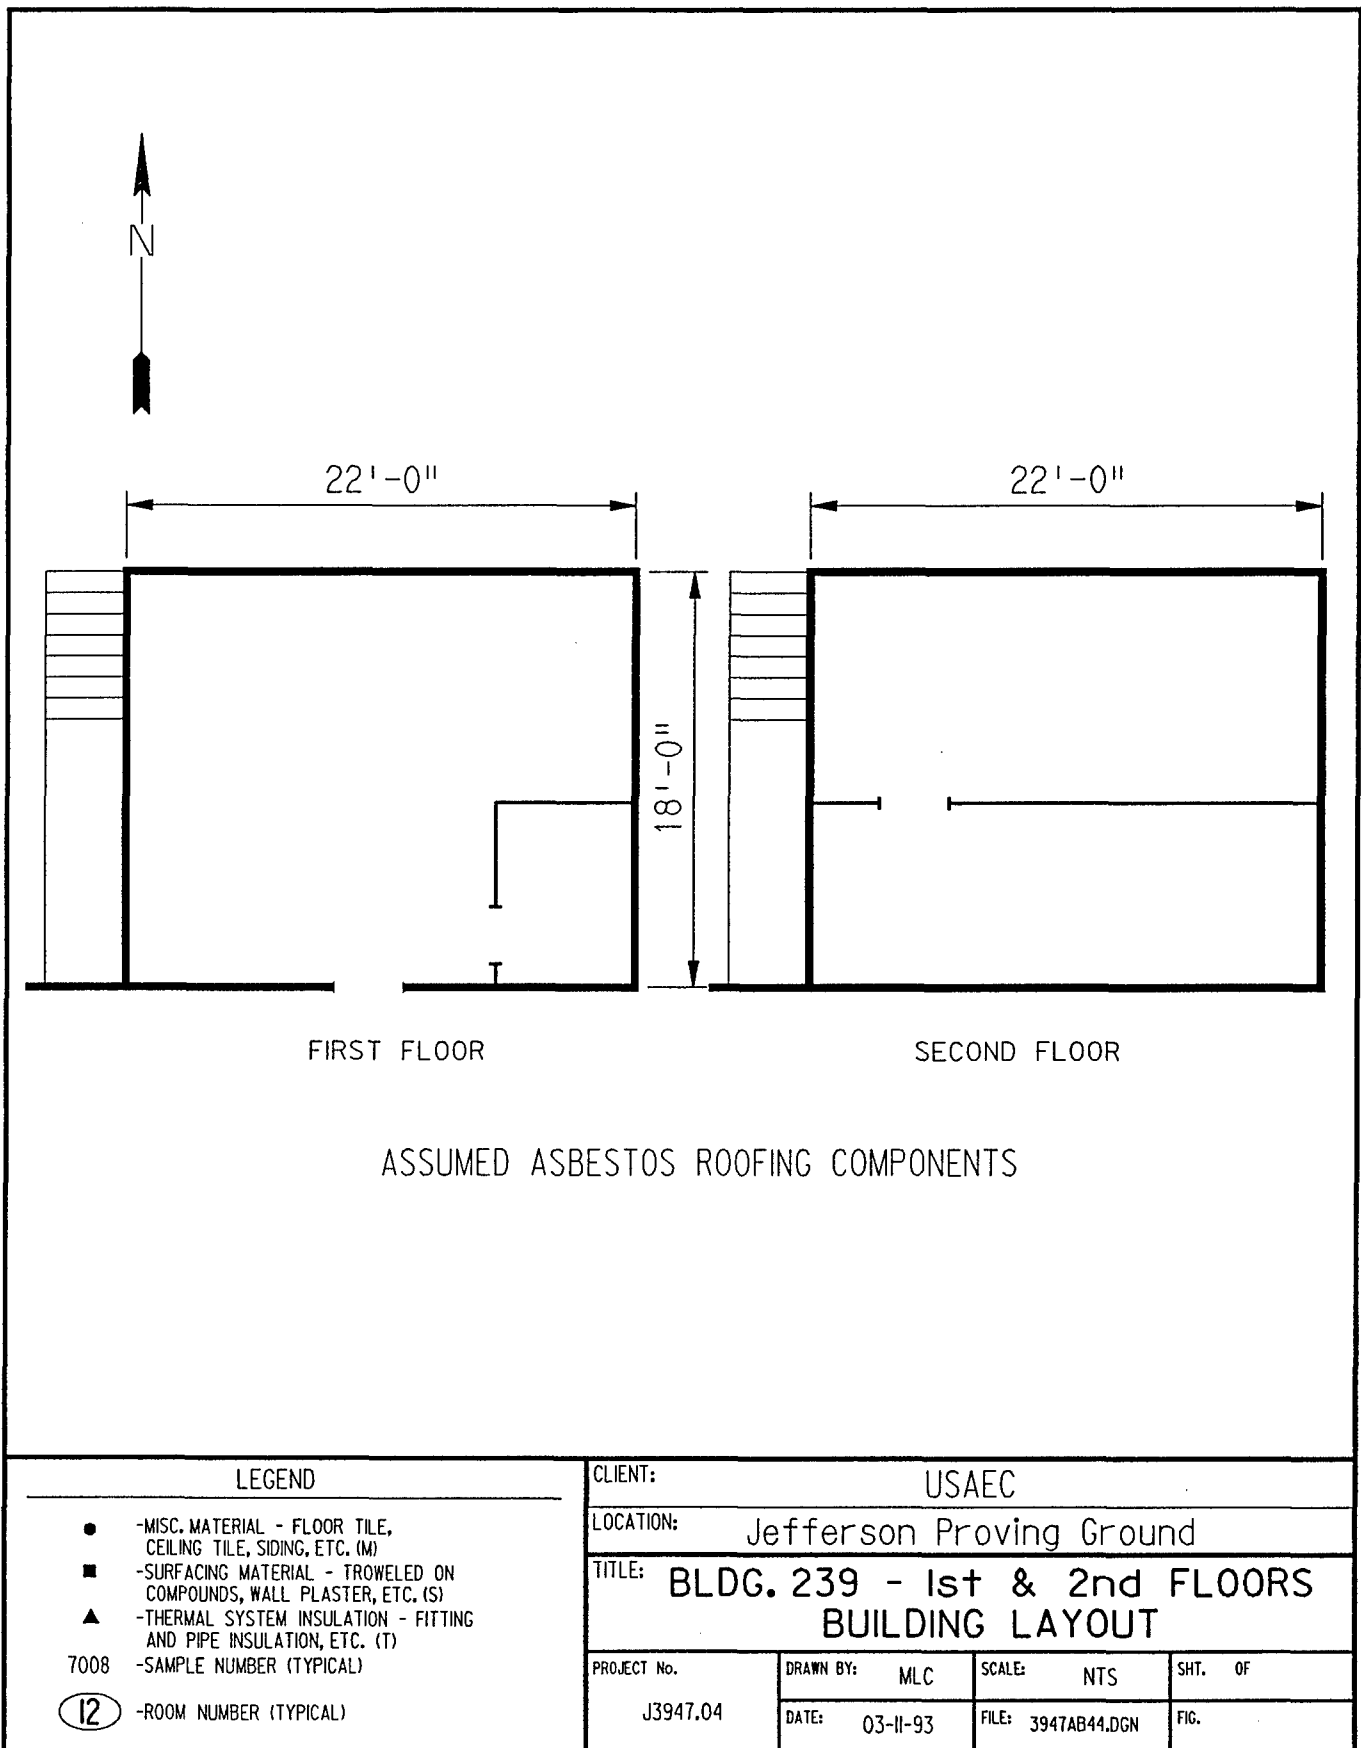
ACM was inaccessible for inspection. These ACM are typically nonfriable and not considered to be a significant environmental concern.

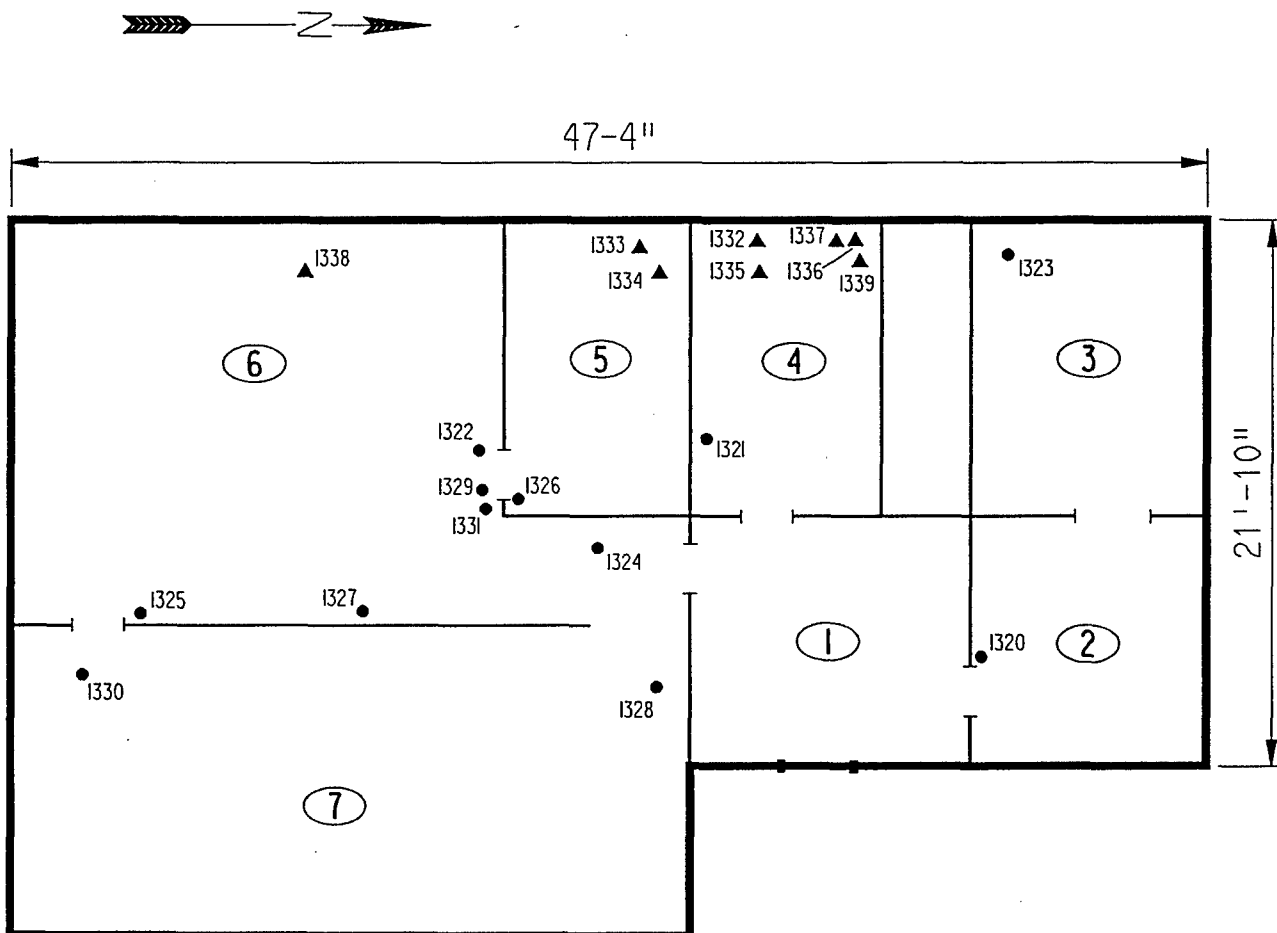
The general condition of ACM present was observed to be good with the noted exceptions above. Pipe insulations were observed to be friable, while other ACMs were nonfriable.

ASSUMED ASBESTOS ROOFING COMPONENTS

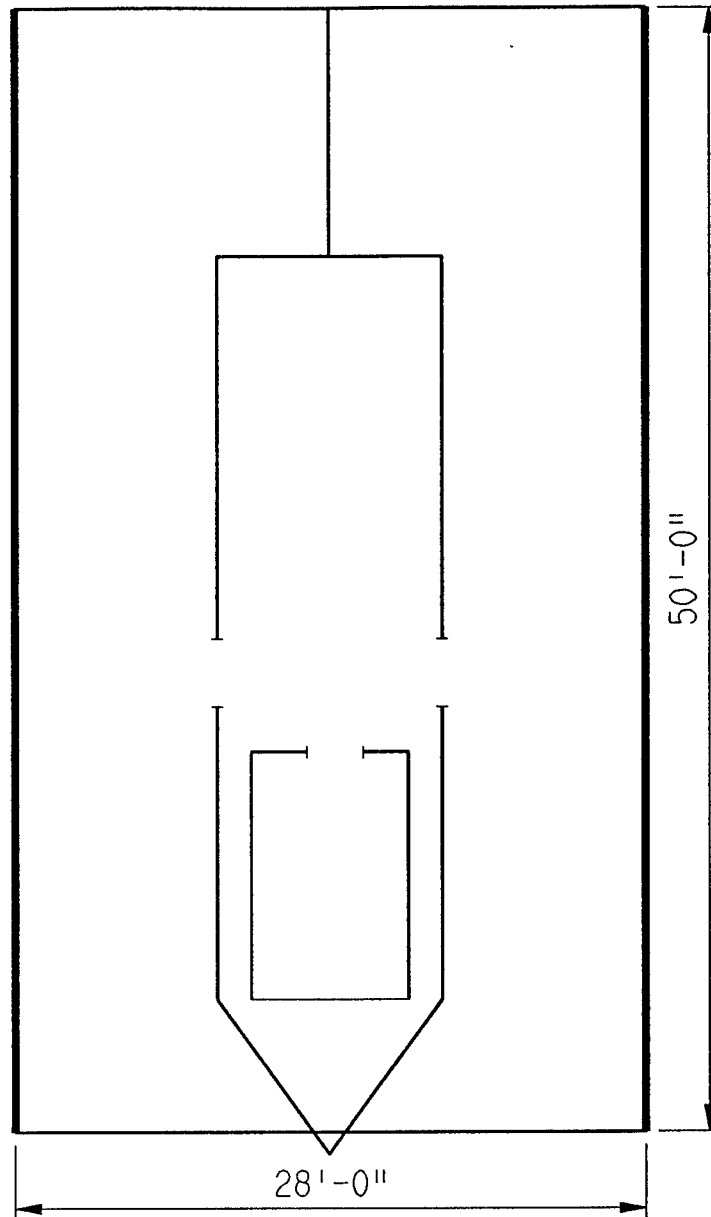
ACM was inaccessible for inspection. This ACM is typically nonfriable and not considered to be a significant environmental concern.

ASSUMED ASBESTOS ROOFING COMPONENTS

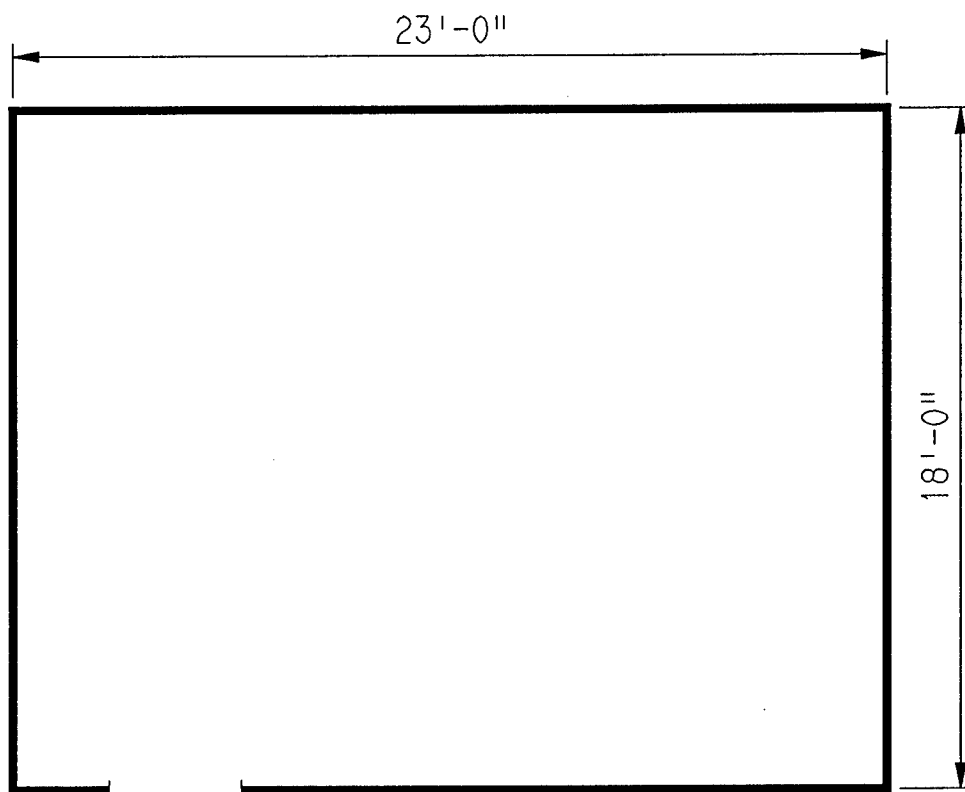
ACM was inaccessible for inspection. This ACM is typically nonfriable and not considered to be a significant environmental concern.

ASSUMED ASBESTOS ROOFING COMPONENTS

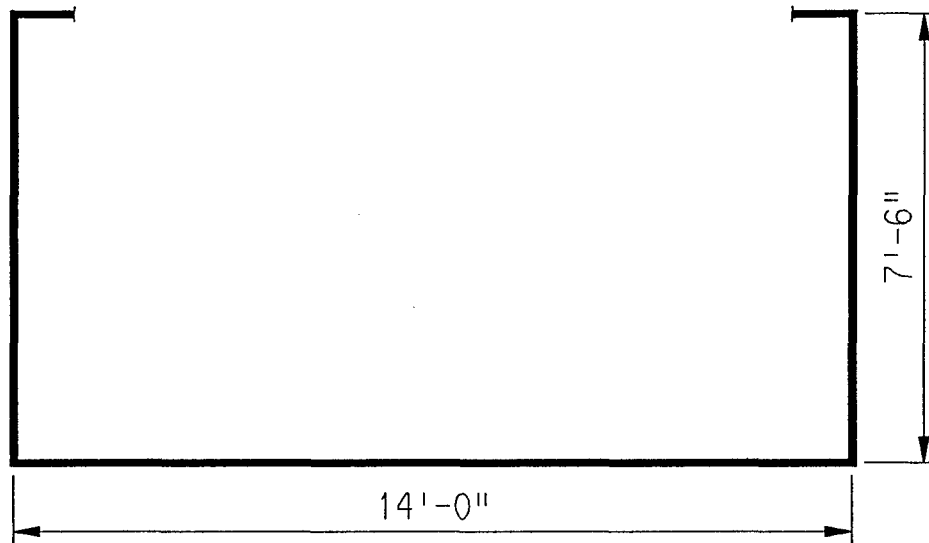
ACM was inaccessible for inspection. This ACM is typically nonfriable and not considered to be a significant environmental concern.

ASSUMED ASBESTOS ROOFING COMPONENTS

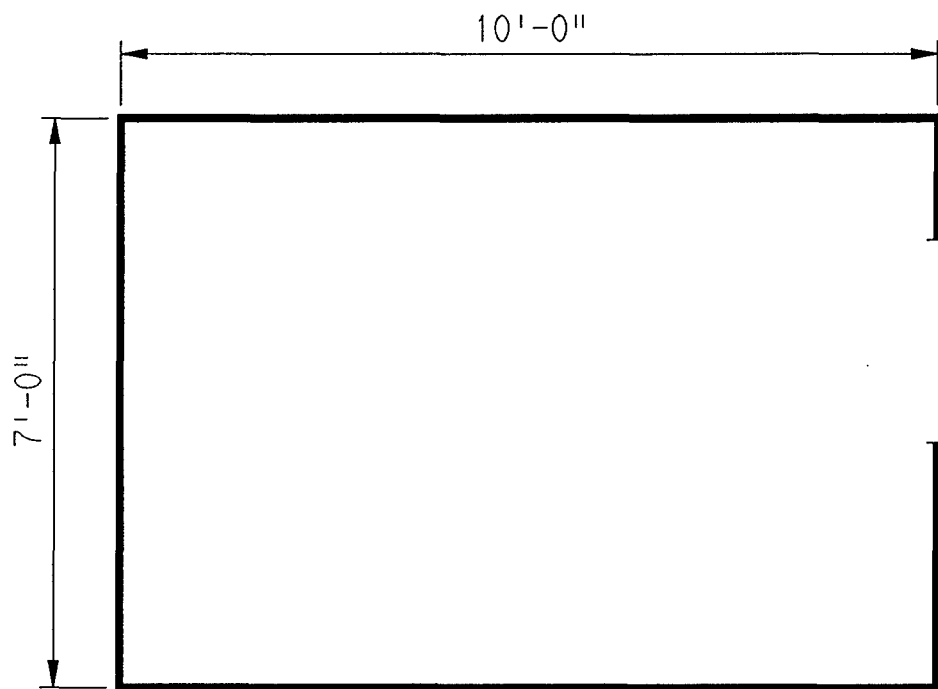
ACM was inaccessible for inspection. This ACM is typically nonfriable and not considered to be a significant environmental concern.

ASSUMED ASBESTOS ROOFING COMPONENTS

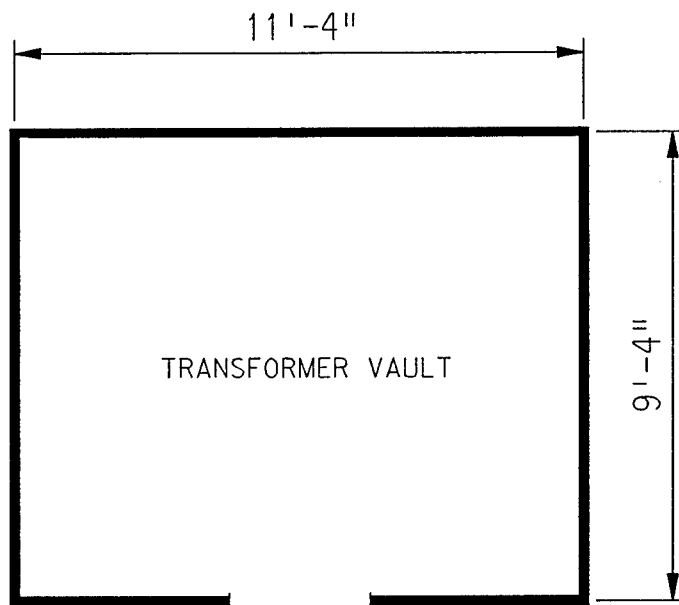
ACM was observed to be nonfriable, and is generally considered not to be a significant environmental concern.

ASSUMED ASBESTOS ROOFING COMPONENTS  
ASSUMED ASBESTOS ELECTRICAL PANEL INSULATION

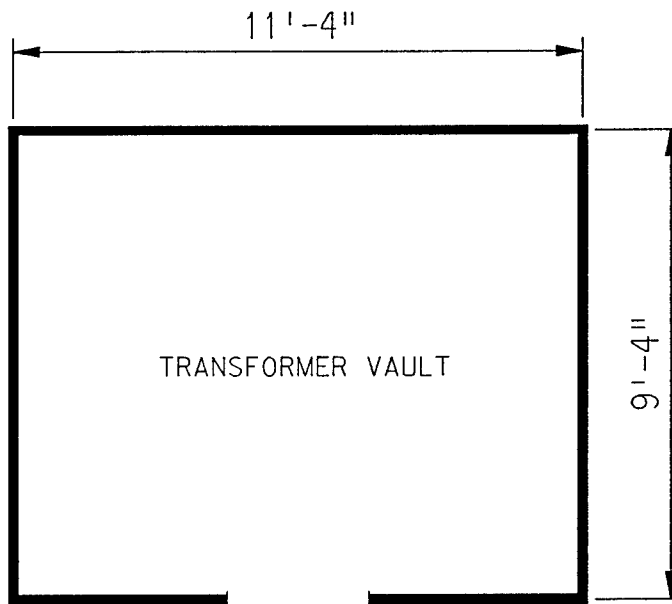
ACM was observed to be nonfriable, and is generally considered not to be a significant environmental concern.

ASSUMED ASBESTOS ROOFING COMPONENTS  
 ASSUMED ASBESTOS ELECTRICAL PANEL INSULATION

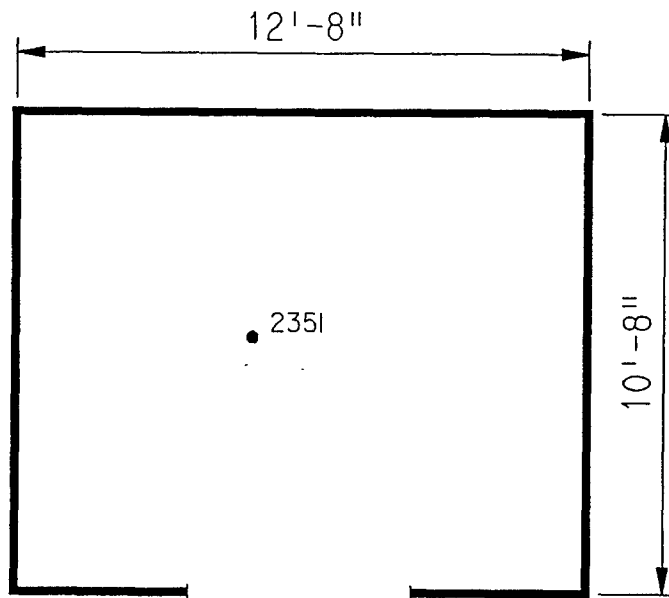
The general condition of ACM present was observed to be good with the noted exceptions above. ACM observed was nonfriable.

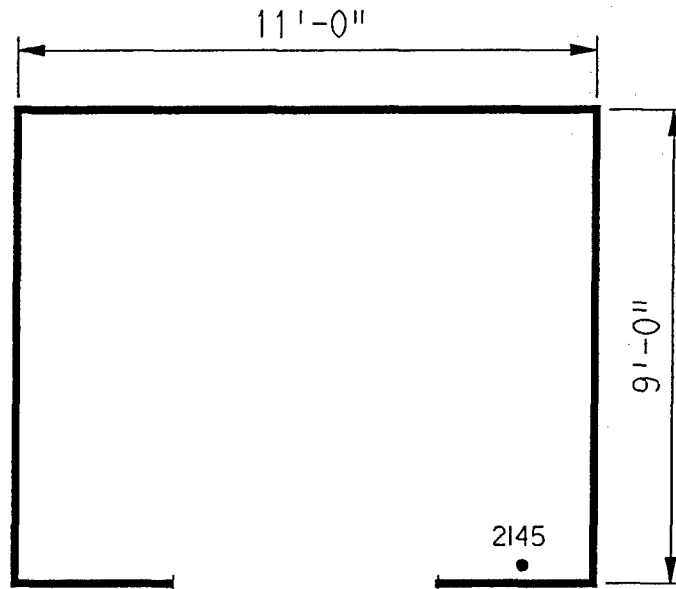
The general condition of ACM present was observed to be good with the noted exceptions above. ACM observed was nonfriable.

ASSUMED ASBESTOS ROOFING COMPONENTS

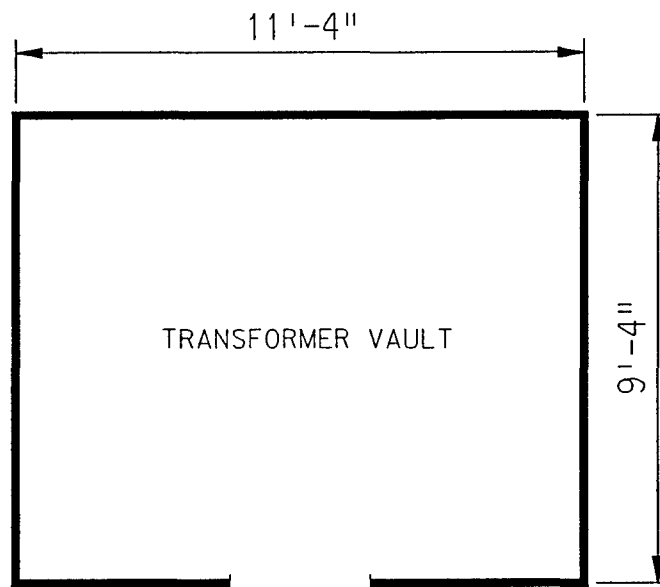
The general condition of ACM present was observed to be good with the noted exceptions above. ACM observed was nonfriable.

ASSUMED ASBESTOS ROOFING COMPONENTS  
 ASSUMED ASBESTOS ELECTRICAL PANEL INSULATION

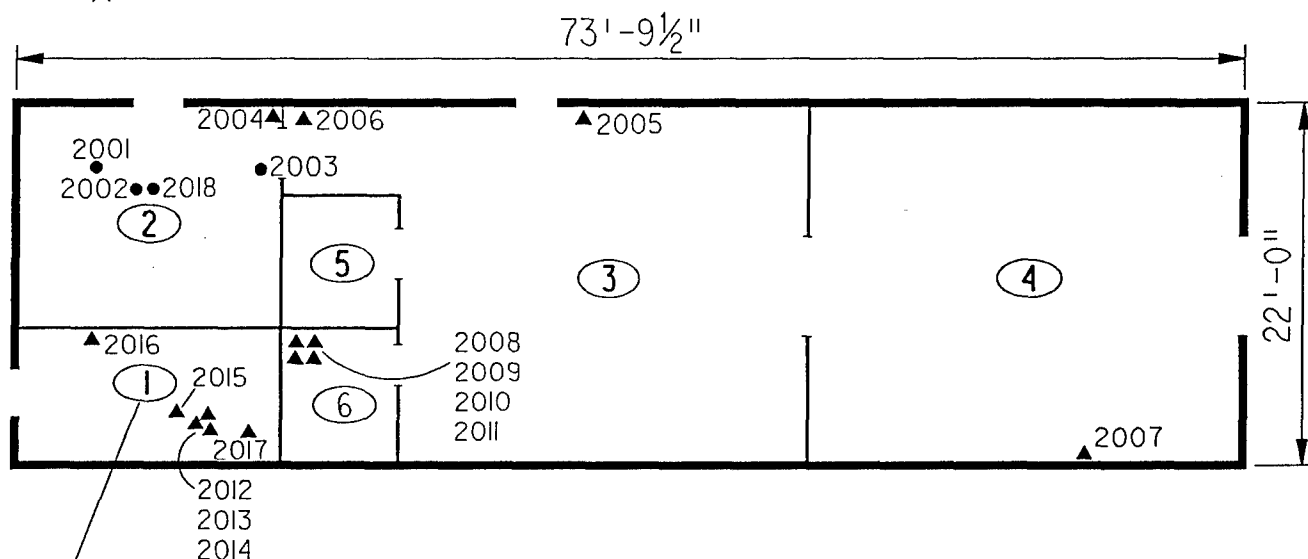
The general condition of ACM present was observed to be good with the noted exceptions above. Pipe insulations were observed to be friable, while other ACM was nonfriable.

### ASSUMED ASBESTOS ROOFING COMPONENTS

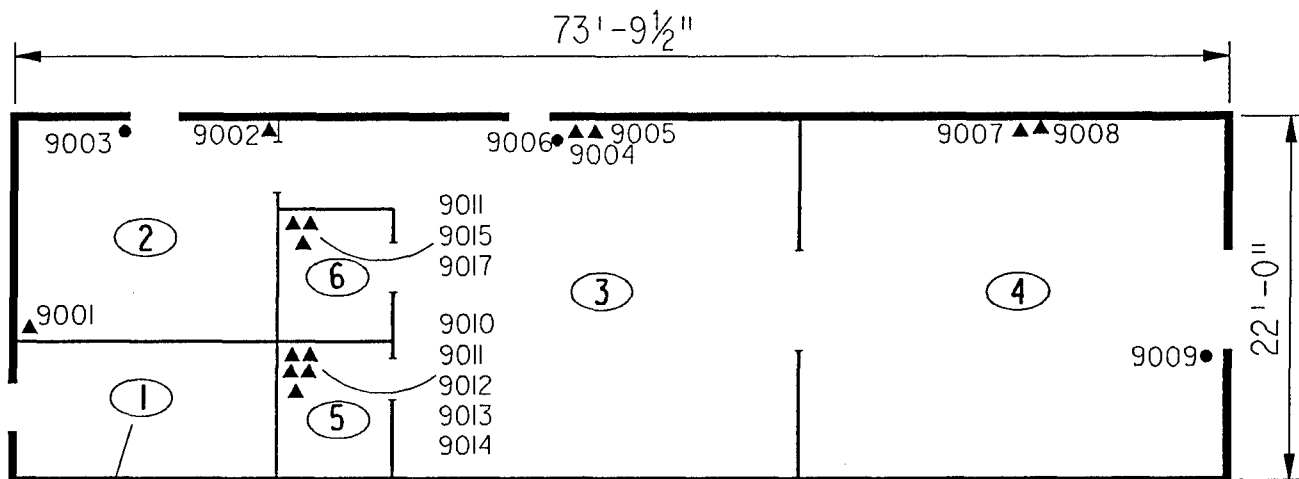
The general condition of ACM present was observed to be good with the noted exceptions above. Pipe insulations were observed to be friable, while other ACMs were nonfriable. The pipe insulation and mudded fitting insulation in the rest rooms received an assessment of damaged to significantly damaged. There are approximately 60 linear feet of pipe insulation and 25 mudded fittings in the rest rooms. The building's plumbing fixtures had been winterized and the water shut off to them, rendering the rest room facilities unusable at that time. Personnel most likely to be exposed to the friable materials would be an occasional worker dropping off or picking up a stored item and inadvertently accessing those rooms. The condition of the friable ACM in this functional space warrants the following recommendation: the building rooms should be locked and posted with an asbestos warning sign to prevent accidental access; and an Asbestos Program Manager, working with an accredited Asbestos Management Planner, should review all pertinent documents and work procedures relating to this building and develop plans to protect workers, future occupants, and the public from the hazards of respirable asbestos.

### ASSUMED ASBESTOS ROOFING COMPONENTS

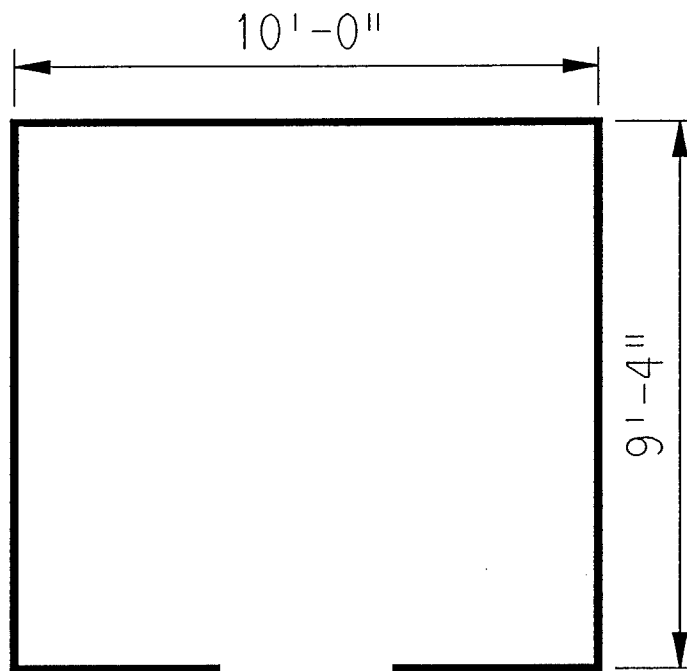
The general condition of ACM present was observed to be good with the noted exceptions above. ACM observed was nonfriable.

ASSUMED ASBESTOS ROOFING COMPONENTS

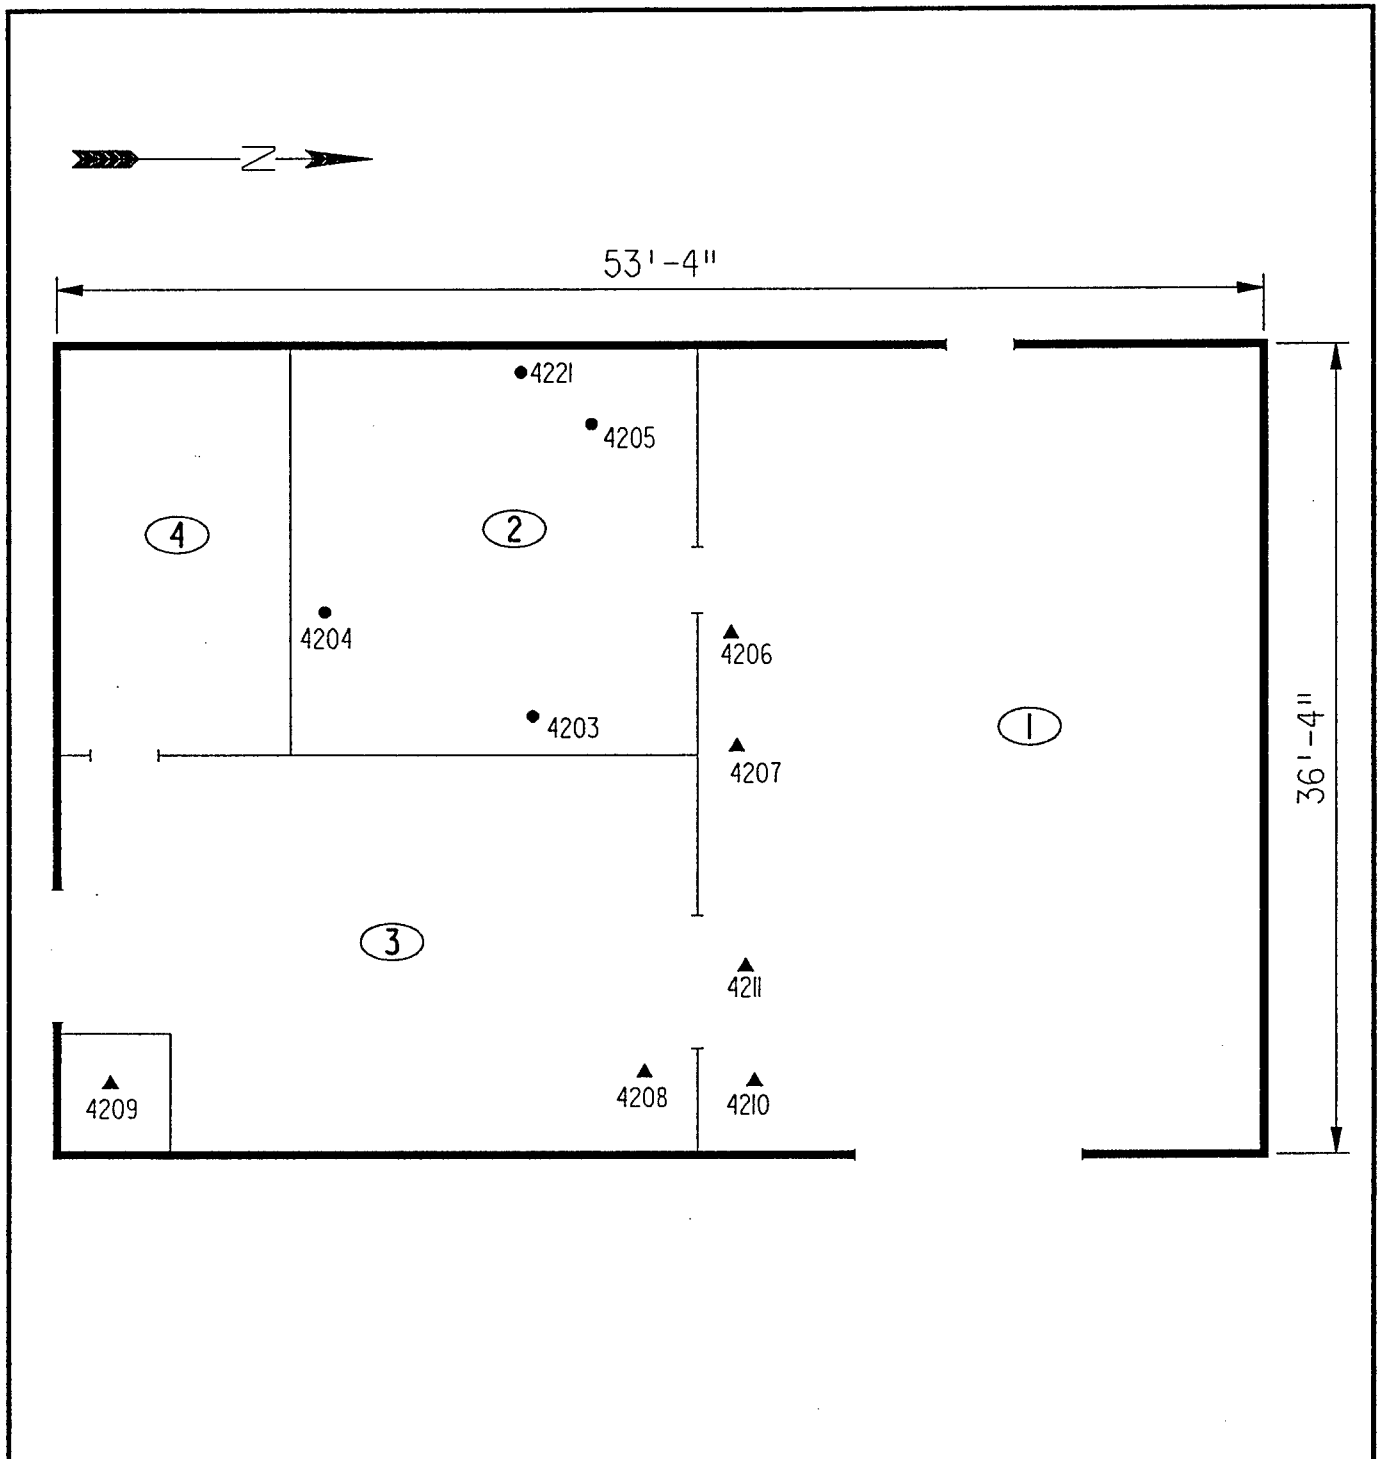
The general condition of ACM present was observed to be fair to good as noted above. Pipe insulations were observed to be friable, while other ACM was nonfriable. Felt wrap pipe insulation was sampled yet the sample results indicated the material as non-ACM, similar material throughout the facility has been sampled and results have identified them as asbestos containing. When these materials are applied, the felt receives varying amounts of asbestos. Further sampling should be performed prior to demolition or renovation.

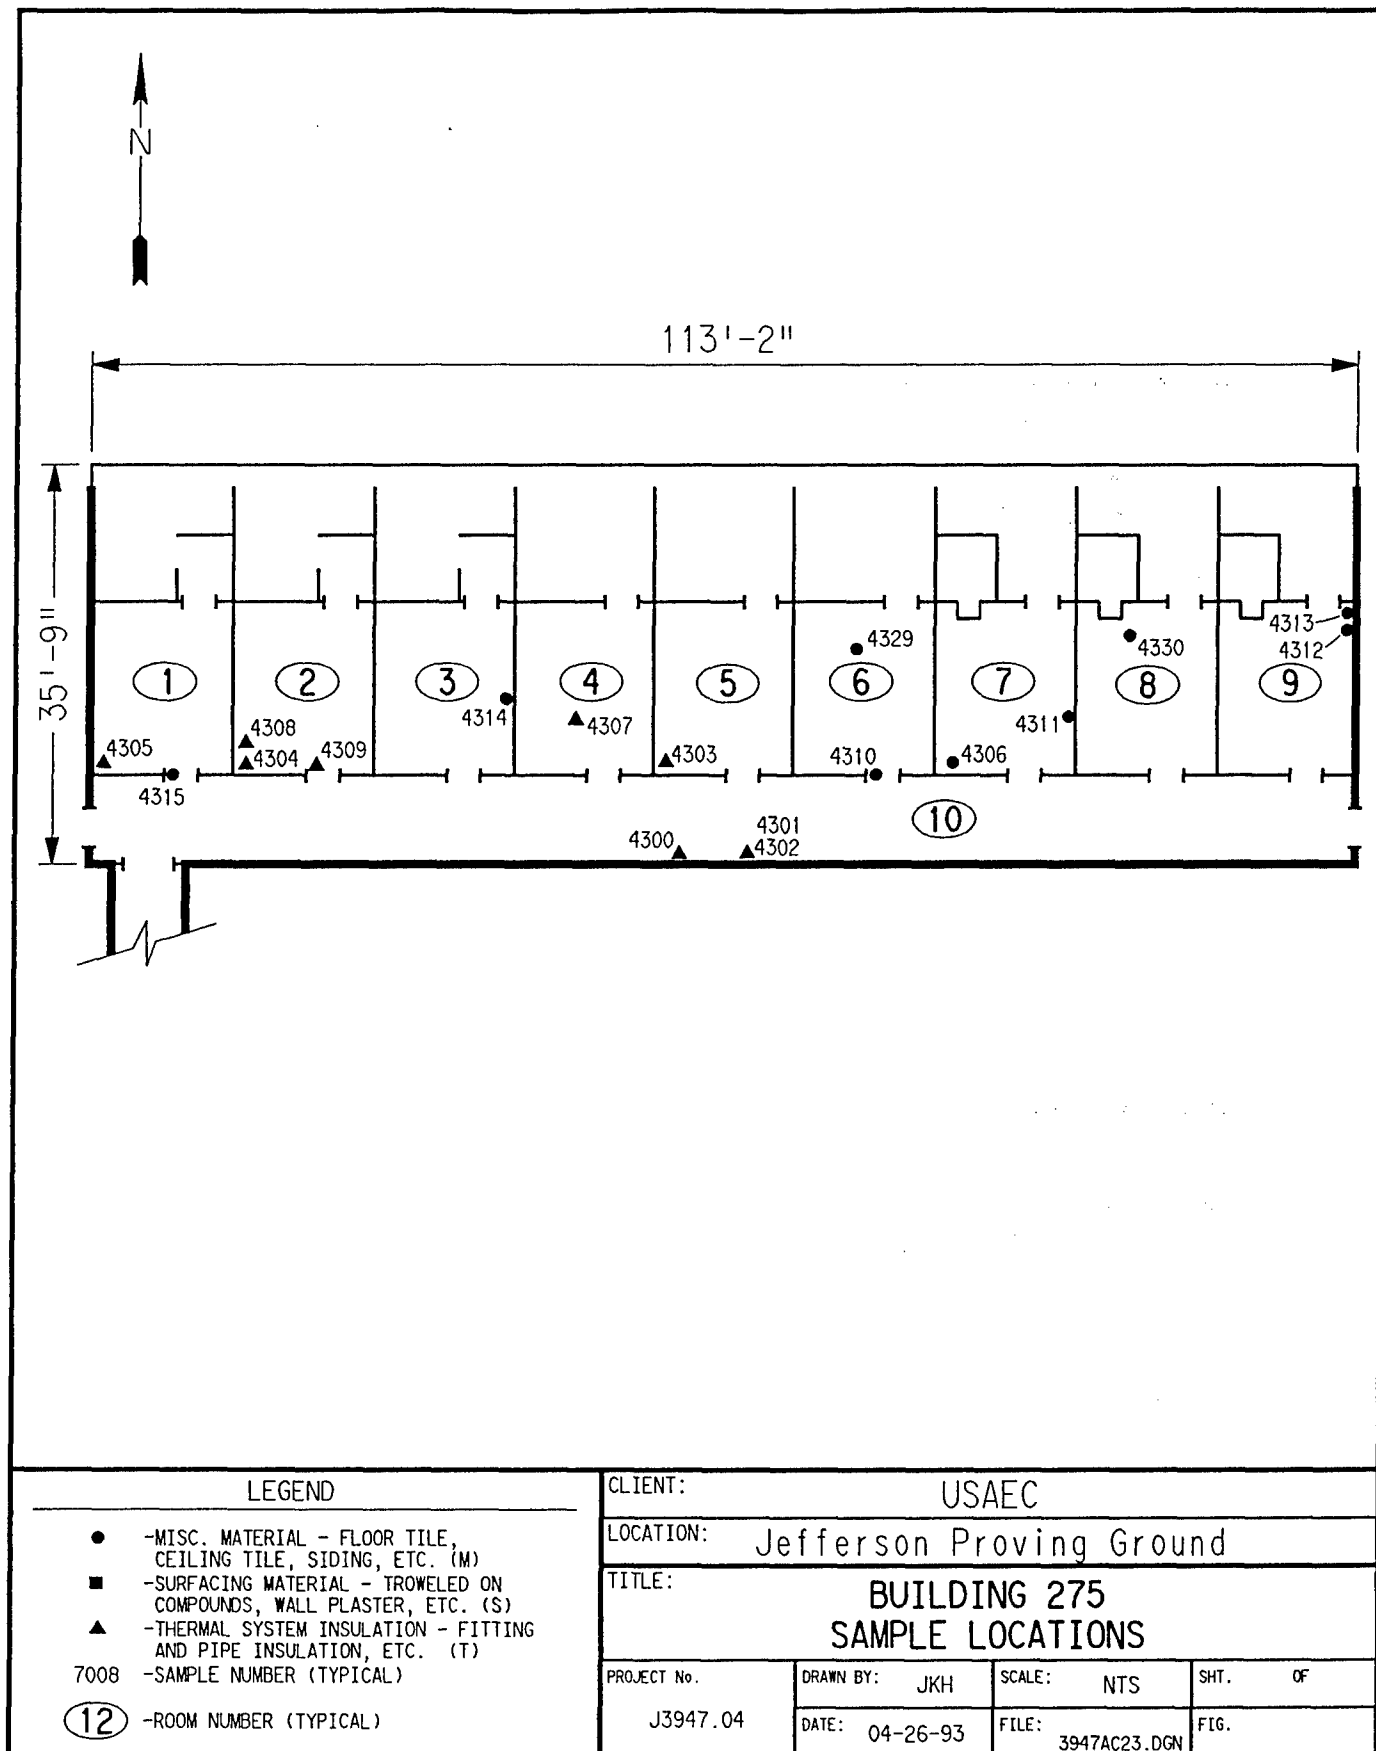
The general condition of ACM present was observed to be fair to good as noted above. Pipe insulations were observed to be friable, while other ACM was nonfriable. It is evident that, because of lack of maintenance, the TSI is deteriorating. If the building usage changes, removal or repairs are recommended.

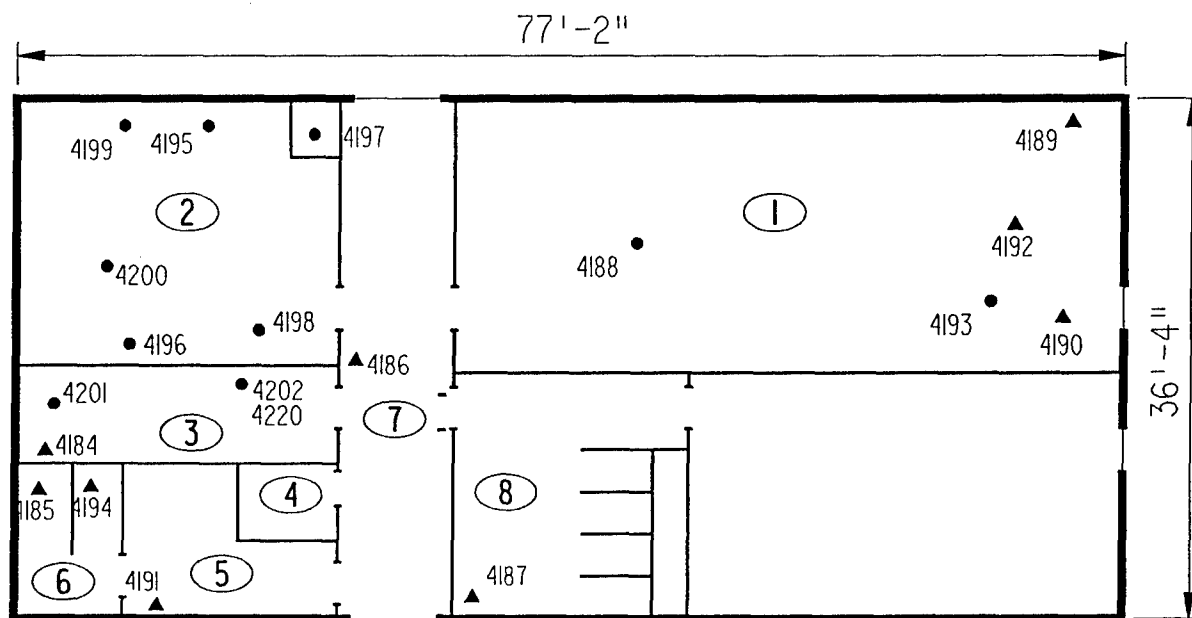
The general condition of ACM present was observed to be fair to good with the noted exceptions above. Pipe insulations were observed to be friable, while other ACMs were nonfriable.

ASSUMED ASBESTOS ROOFING COMPONENTS

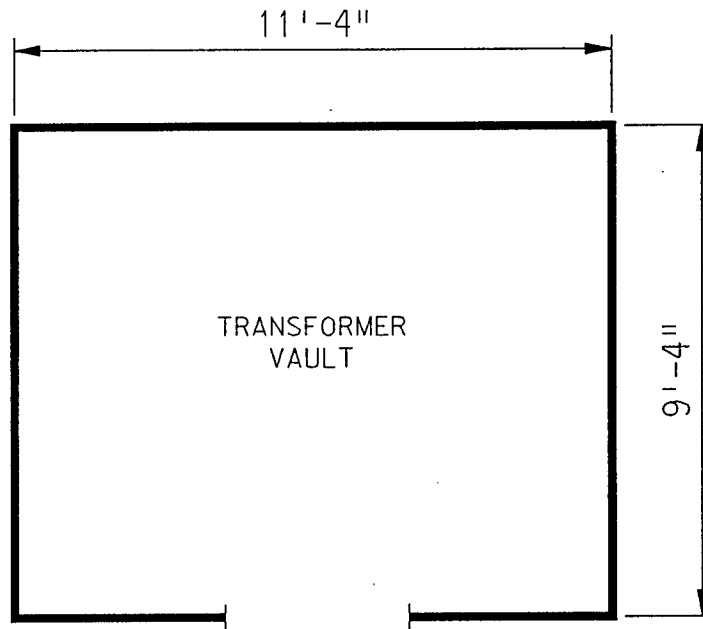
The general condition of ACM present was observed to be good with the noted exceptions above. ACM observed was nonfriable.

ASSUMED ASBESTOS ROOFING COMPONENTS  
 ASSUMED ASBESTOS ELECTRICAL PANEL INSULATION
